# ALAM

## Newsletter

Autumn 2008

**The Association of  
Lecturers in Agricultural Machinery**

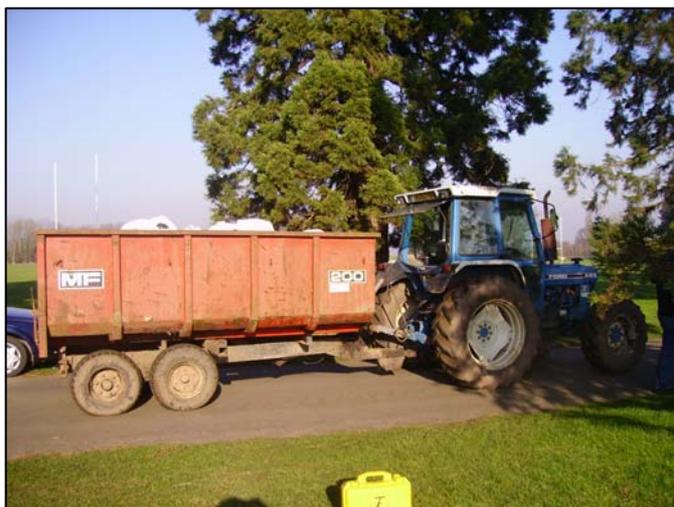
The meter can simply be placed on the floor of any tractor to measure braking forces, and can print an on-the-spot record of the results.

Warwickshire College provided a Ford 6410 4wd (mass 3000kg) and Massey Ferguson 200 twin axle trailer (mass 2500kg). The trailer had a load of 3000 kg.

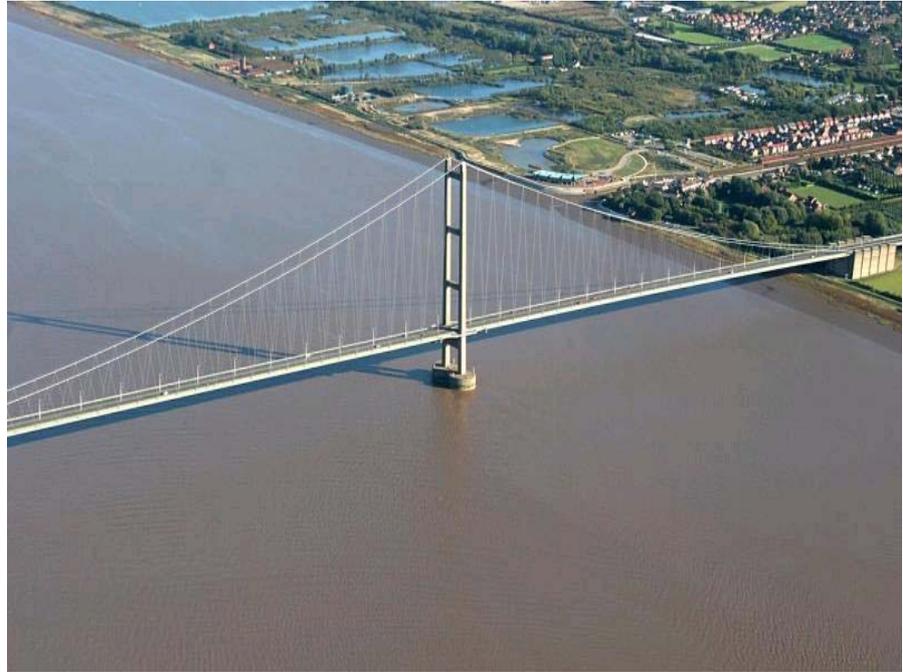
The bridge is held up by main cables. Each cable consists of 14, 948 parallel galvanised drawn steel wires of 5mm diameter. After construction, they were tightly compacted, coated with red lead paste and wrapped in soft galvanised iron wire to form a casing. The bridge is suspended from the main cables by spiral strand steel wire ropes called hanger ropes, 62mm in diameter. The road is a 2-lane carriageway with combined footways/cycle tracks and was constructed by

welding together 124 prefabricated steel box sections 18.1m long and 4.5m deep formed from stiffened steel plate panels. The anchorages are huge concrete structures each containing two chambers within which the main cables splay out into separate strands and attach to steel crosshead slabs at the face of anchor blocks by the strand shoes and anchor bolts.
